Manhole Inspection Summary

Manhole # S29YY1008MH

Location Address: **107 COTSWORLD RD**

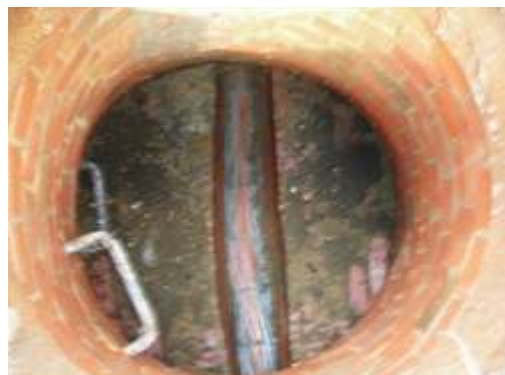
Top View

Bench debris.

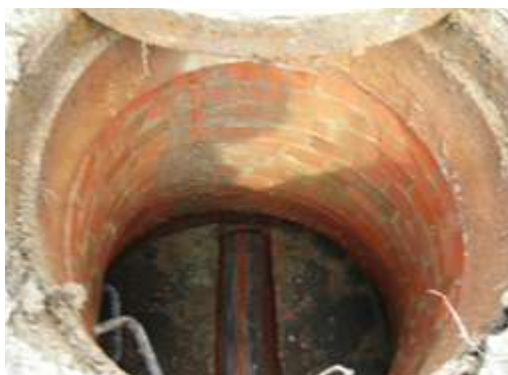
Defect

Frame leaks. Adjustment and Barrel infiltration.

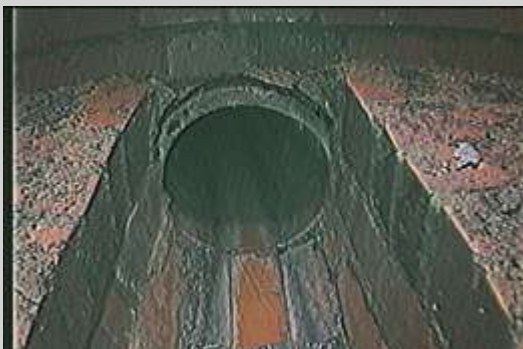
8 in. Circular Gravity Sewer Pipe In @ 6 O'Clock

Channel deterioration.

Infiltration: **Evidence** Pipe Seal Cond: **Unknown**
